# STUDY OF CRACK INITIATION PHENOMENA ASSOCIATED WITH STRESS CORROSION OF ALUMINUM ALLOYS

FINAL SUMMARY REPORT

ALCOA RESEARCH LABORATORIES  
NEW KENSINGTON, PA

October 6, 1969

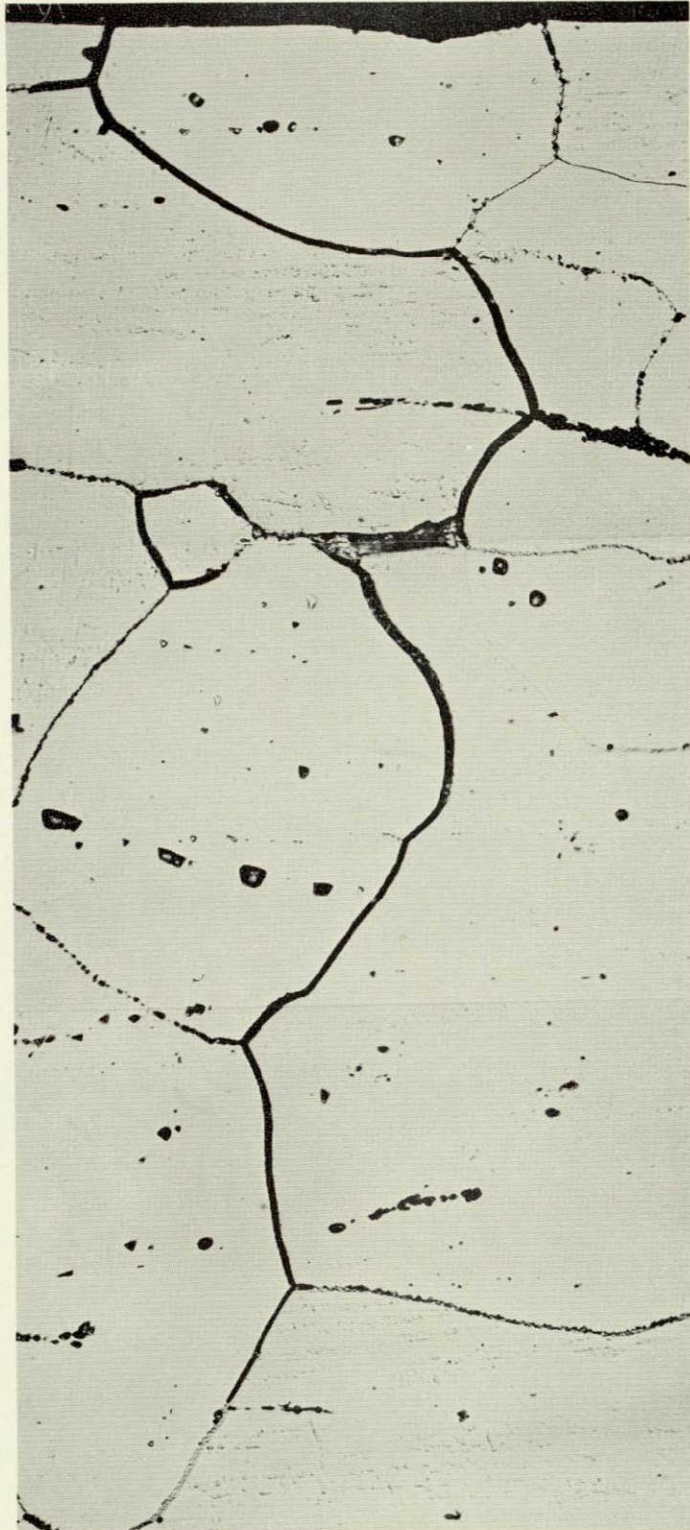
Figure 124

Crack development in X7375-T6 stressed to 75% YS  
longitudinally (X500). Compare with Fig. 123.

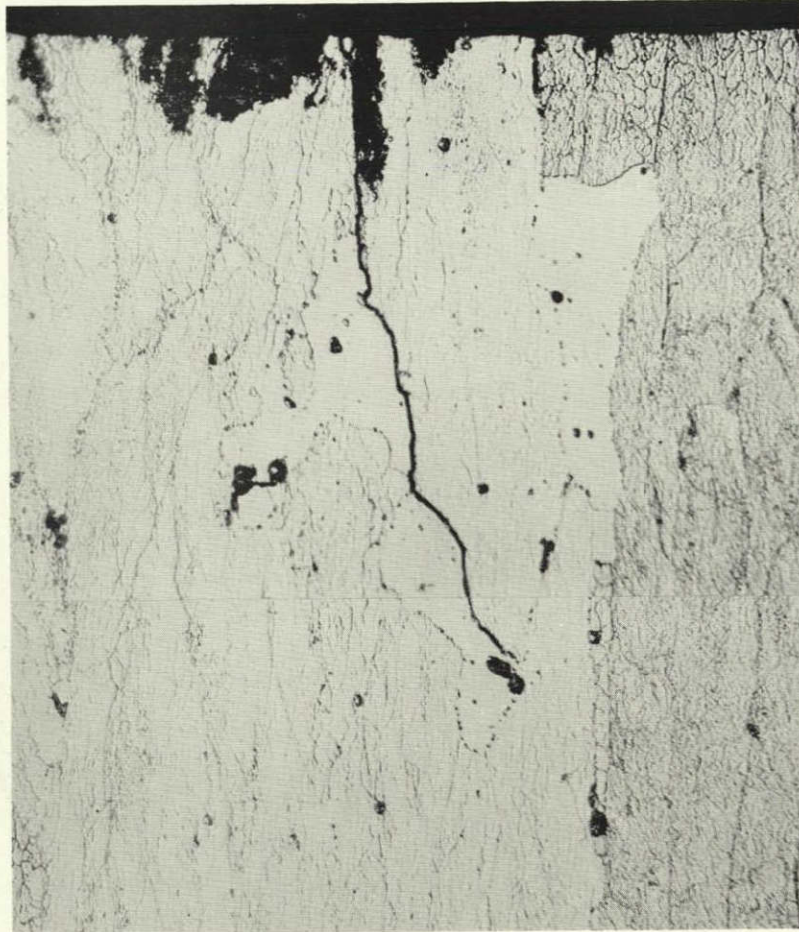
Figure 133

Cross section of crack seen in Fig. 132 (X500).

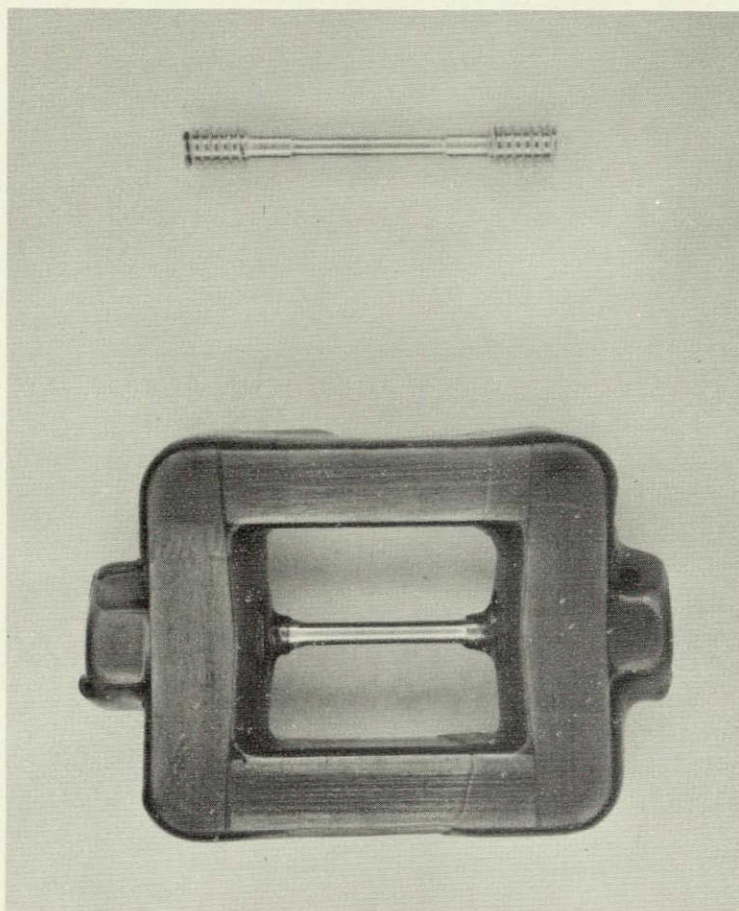
Figure 136

Actual size photograph of an 0.125 in. diameter x 2 in. long threaded-end tension specimen (top) together with a similar specimen assembled in an Alcoa "constant deformation" type stressing frame (bottom). The latter was covered with a strippable cellulose acetate coating to prevent electrochemical effects between specimen and frame.

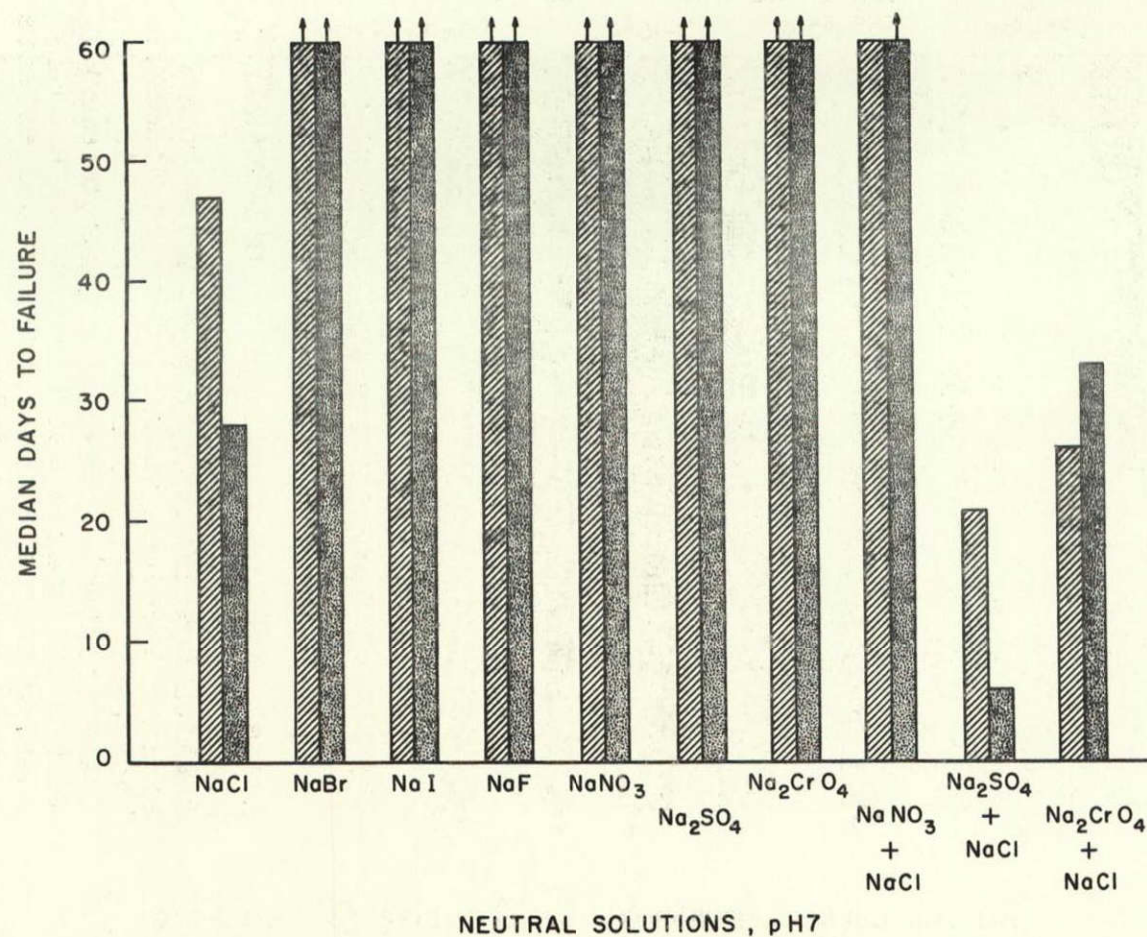
EFFECT OF ENVIRONMENT ON RESISTANCE TO STRESS-CORROSION CRACKING  
FIGURE 137

O.125 IN. DIA , SHORT TRANSVERSE TENSILE SPECIMENS - STRESSED 75% Y.S.

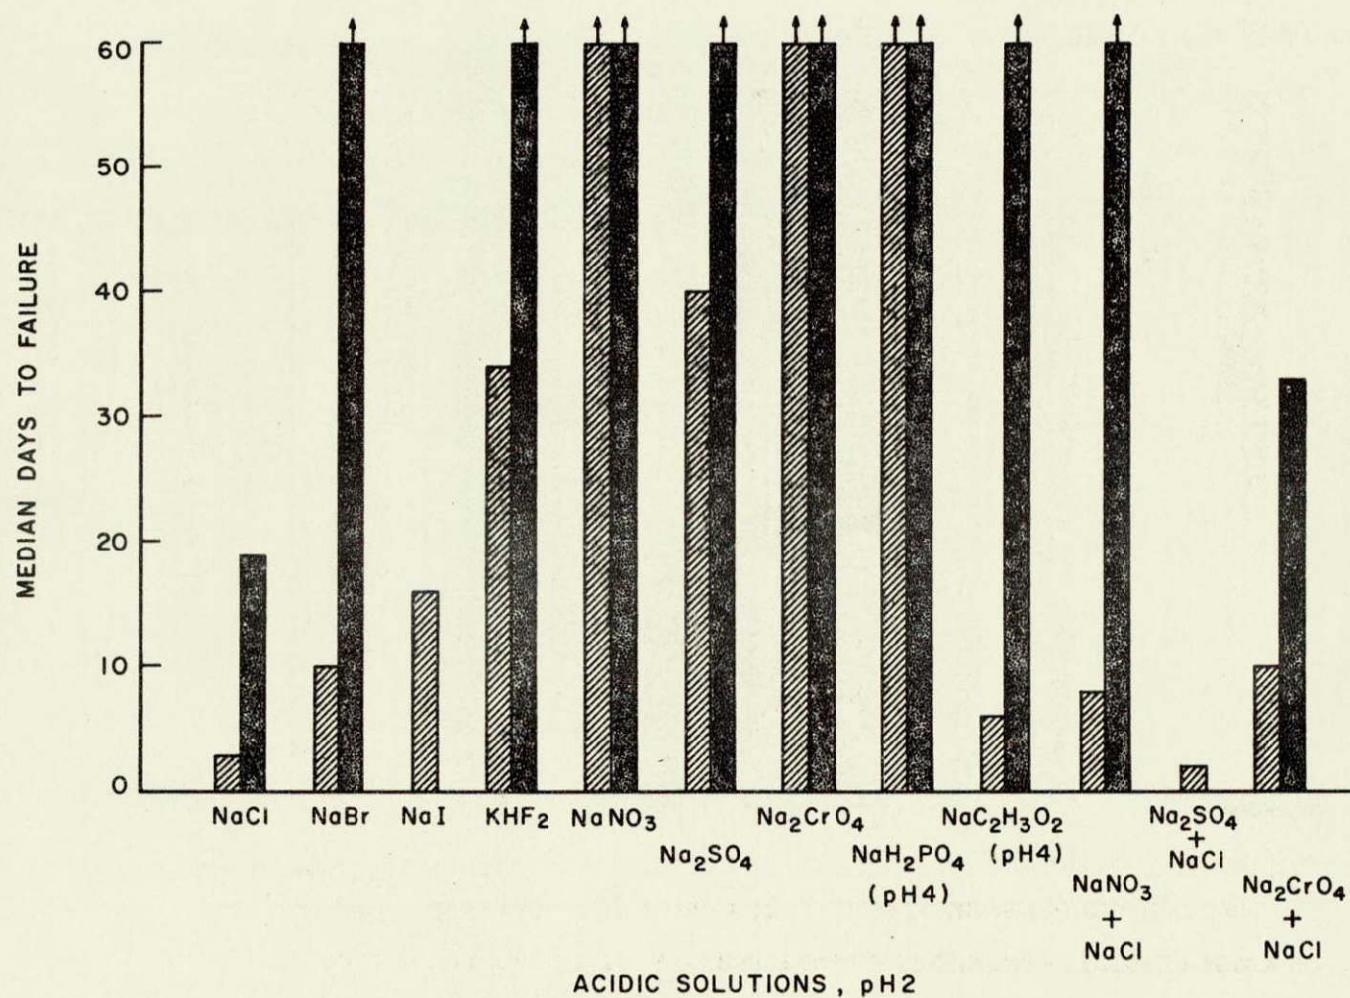
FIGURE 138

EFFECT OF ENVIRONMENT ON RESISTANCE TO STRESS-CORROSION CRACKING

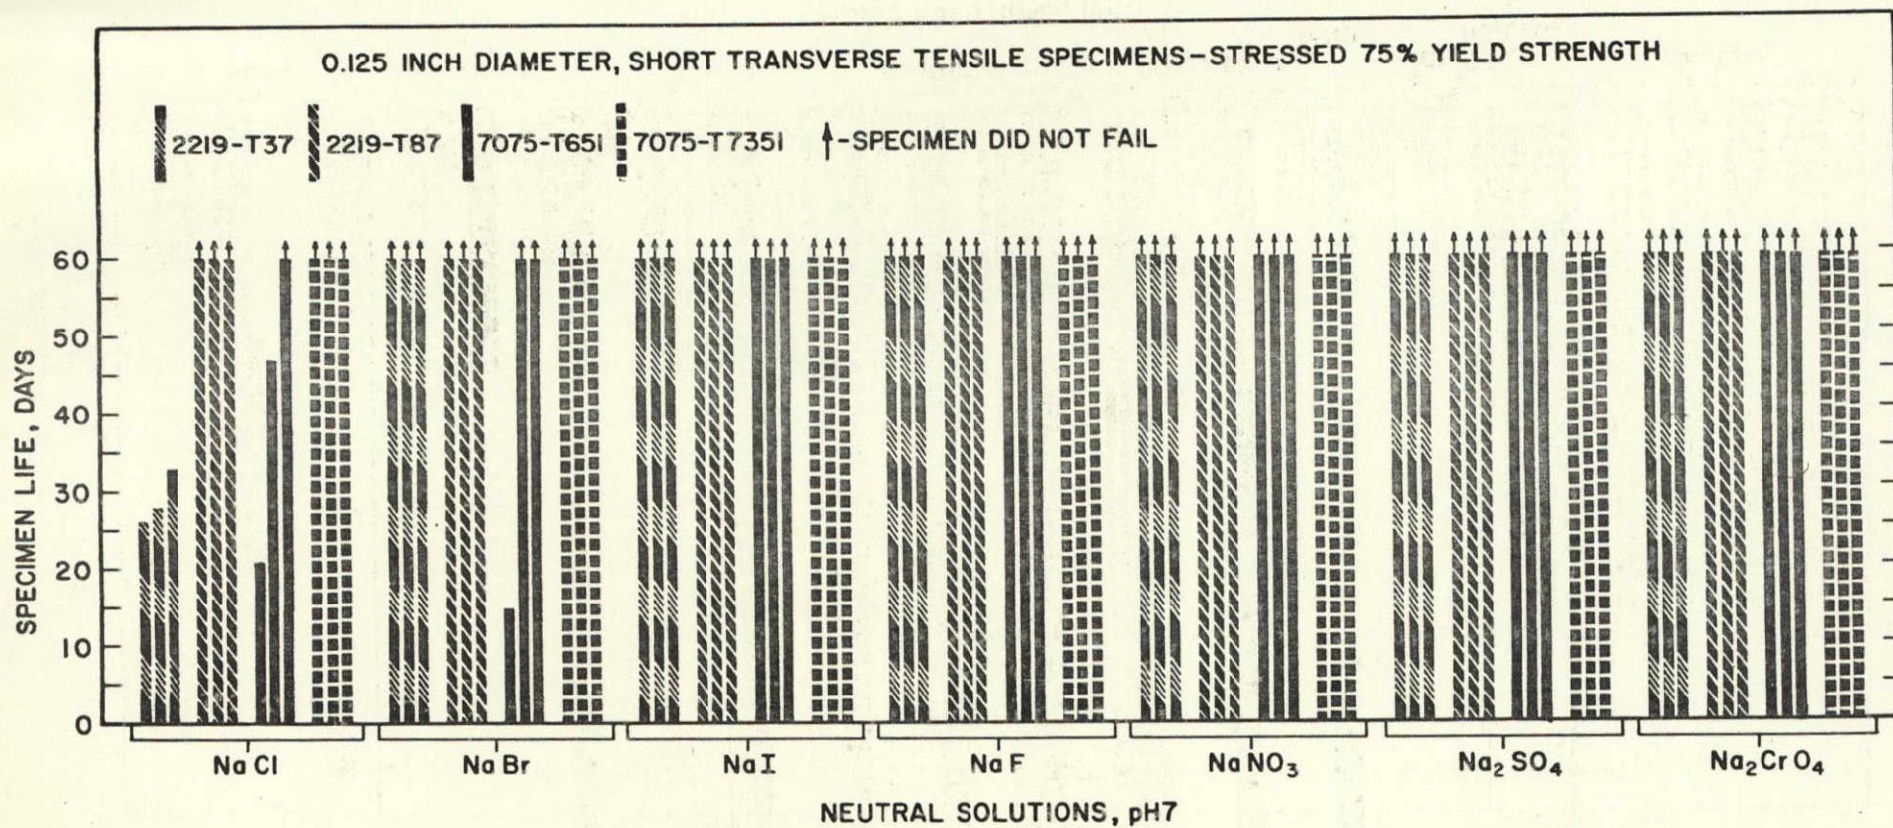
FIGURE 139

EFFECT OF ENVIRONMENT ON RESISTANCE TO STRESS—CORROSION CRACKING

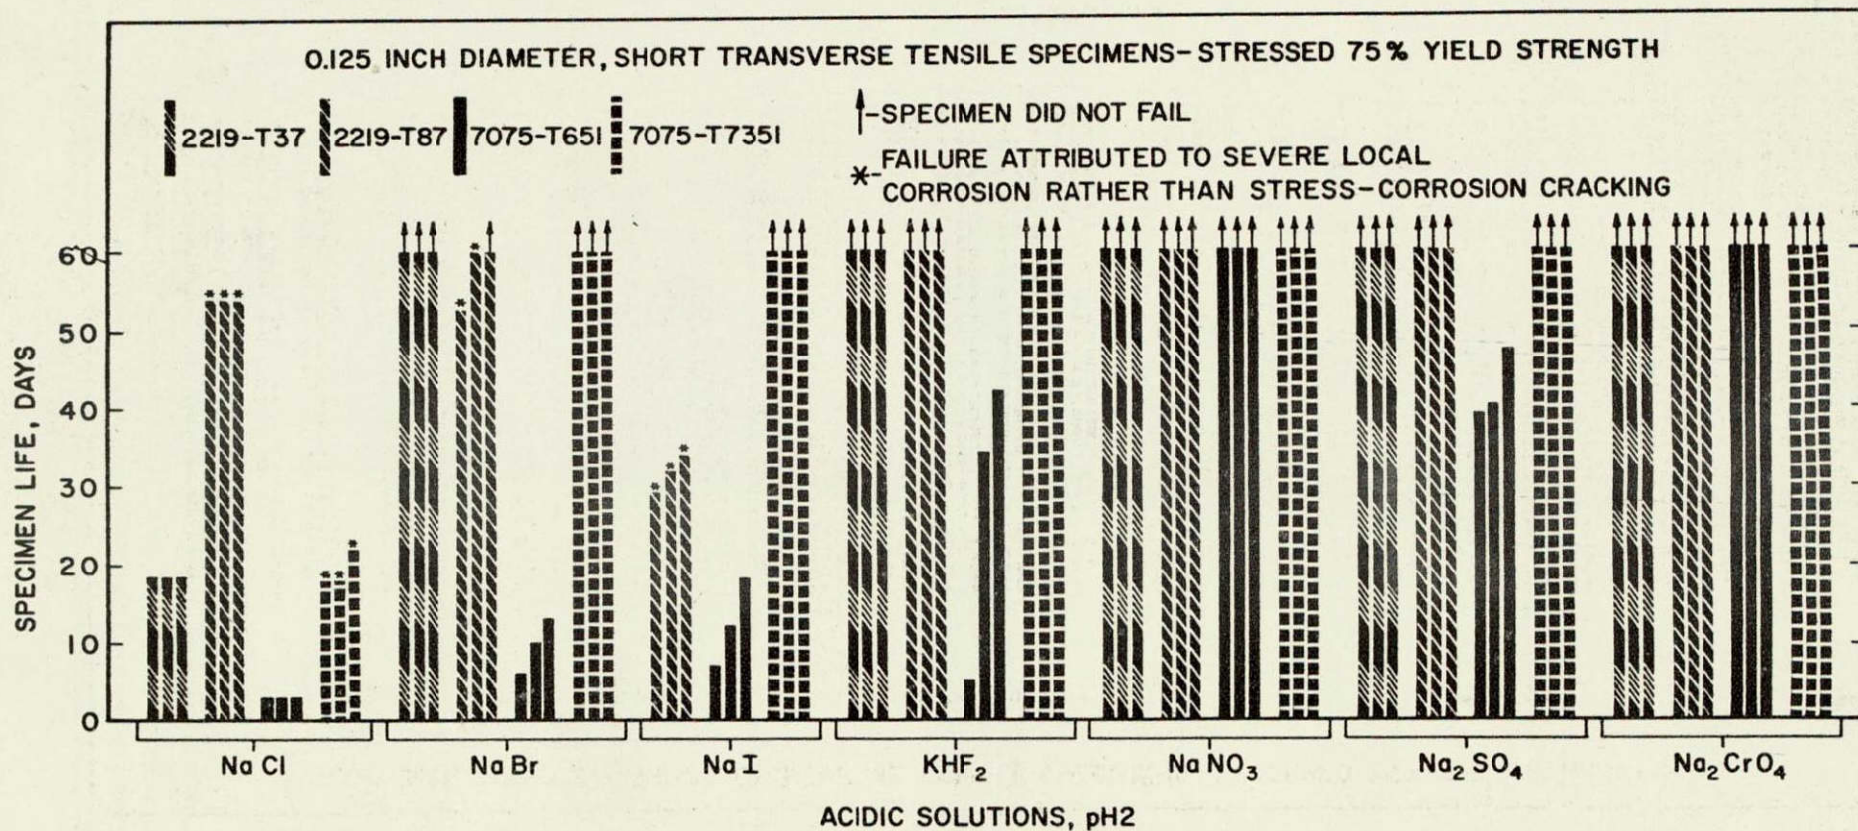
FIGURE 140

EFFECT OF ENVIRONMENT ON RESISTANCE TO STRESS-CORROSION CRACKING

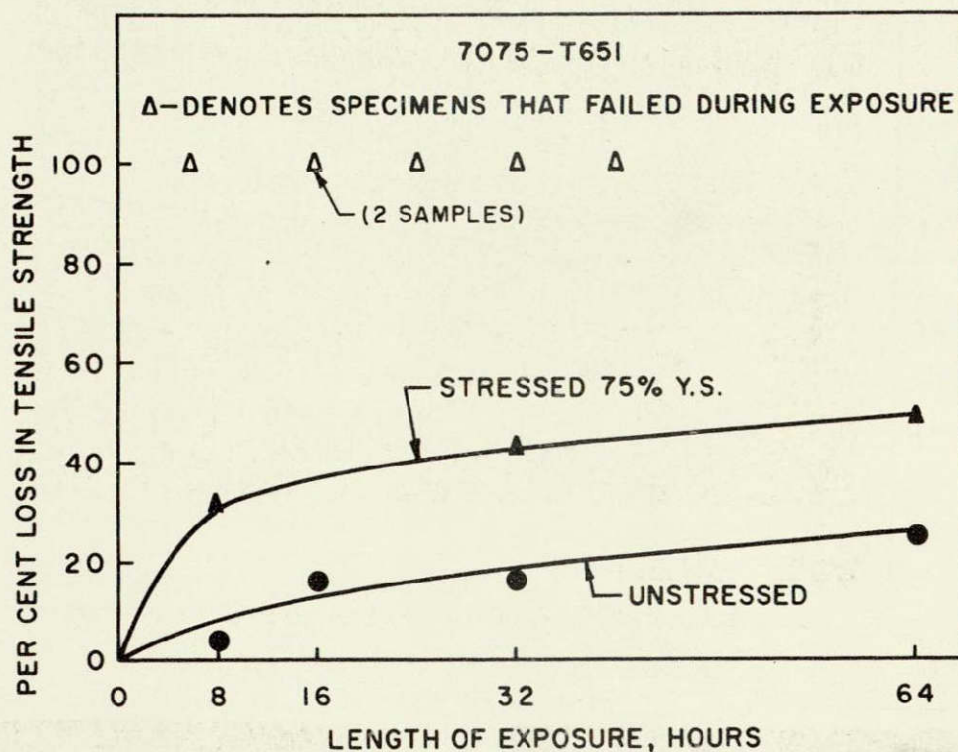
FIGURE 144

EFFECT OF STRESS ON CORROSION RATE OF 7075 ALLOY IN ACIDIFIED  
NaCl (pH2)

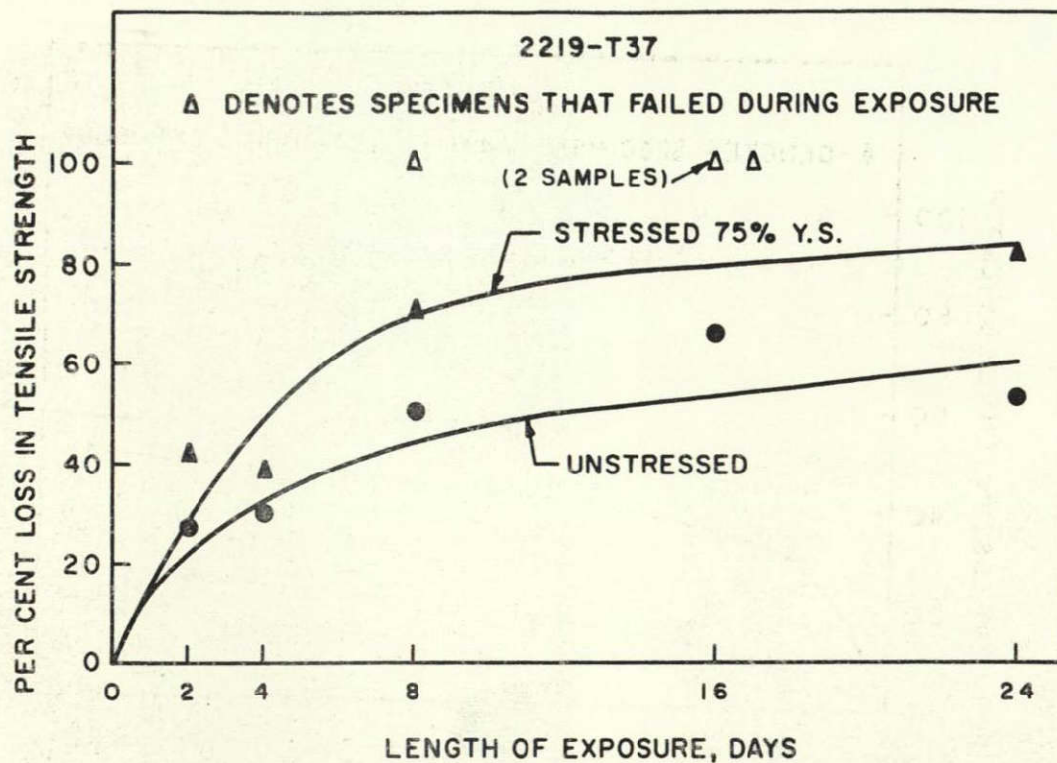
FIGURE 145

EFFECT OF STRESS ON CORROSION RATE OF 2219 ALLOY IN ACIDIFIED  
NaCl (pH2)

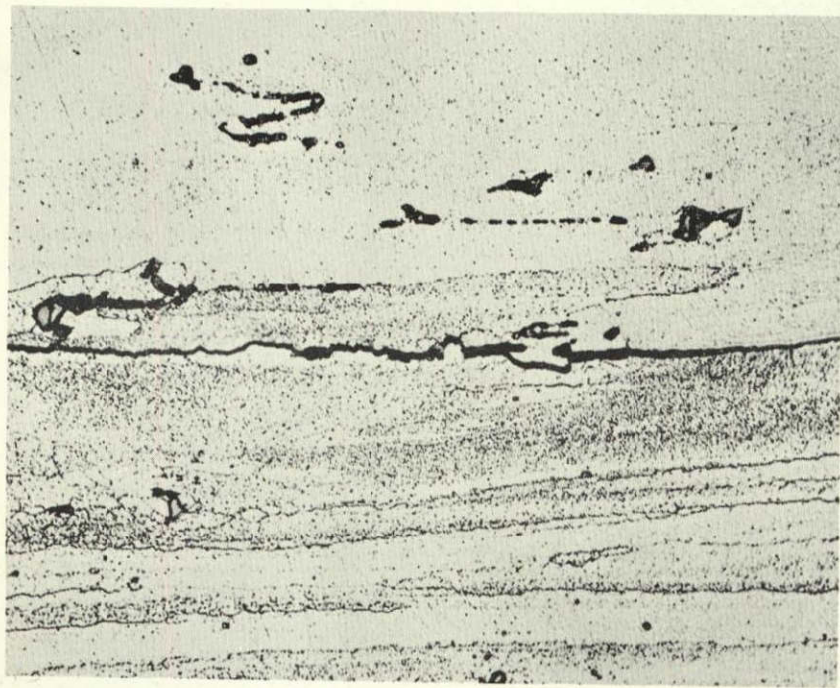
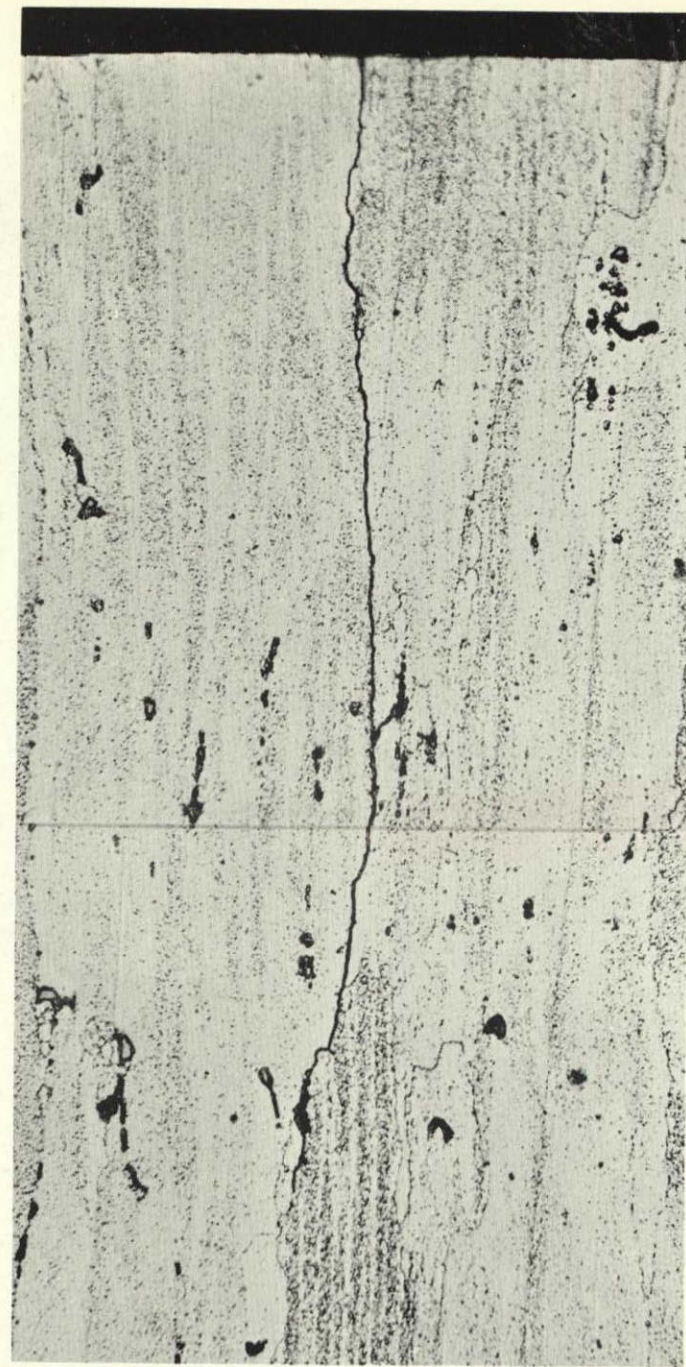
Boundary path of cracks in Fig. 154 as seen on surface  
(left) and in cross section (right). Keller's Etch. (X500)

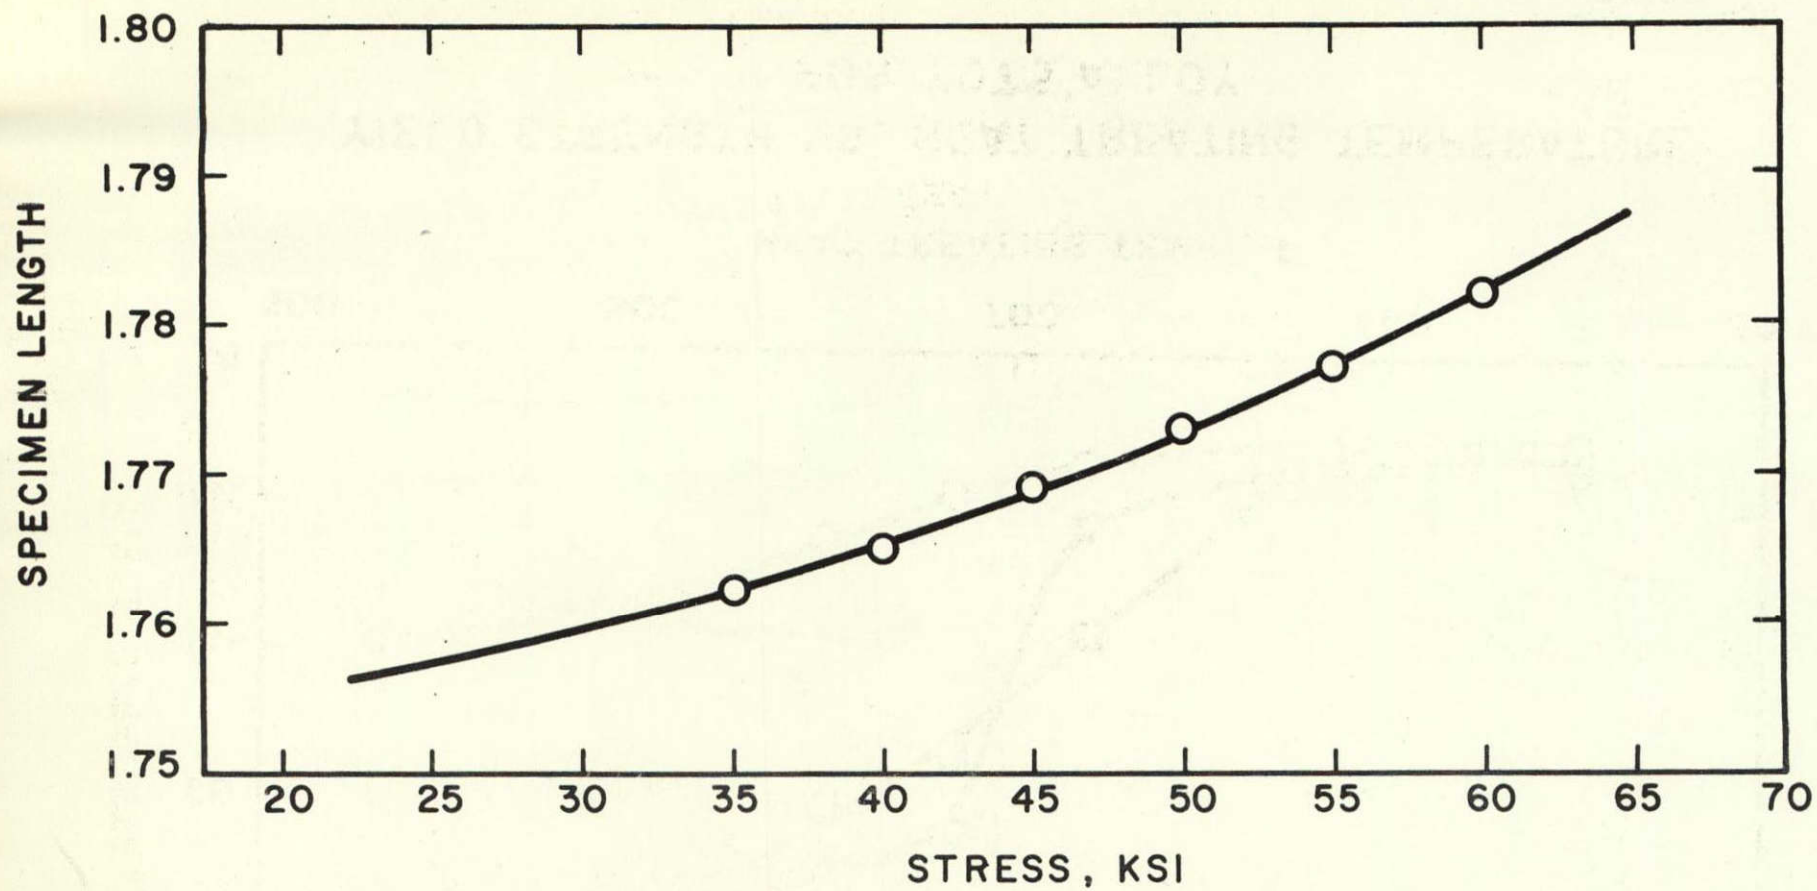
FIGURE 161

RELATION BETWEEN STRESS AND SPECIMEN LENGTH FOR 0.25 IN.  
SHEET SPECIMENS OF 7075 AND 7039 ALLOYS IN 1.75 IN. SPAN FIXTURE
